# CAISSON INSPECTION & COMPOSITE REPAIR

- Rope access deployed caisson repair

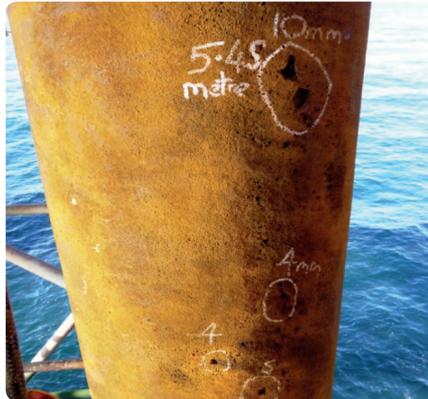
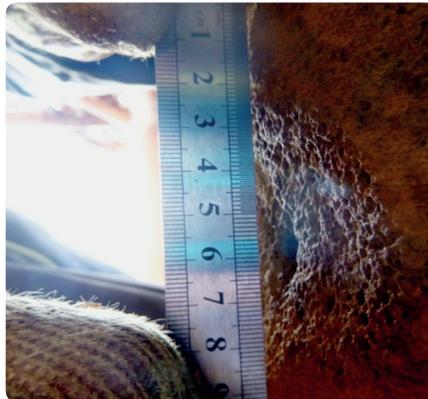
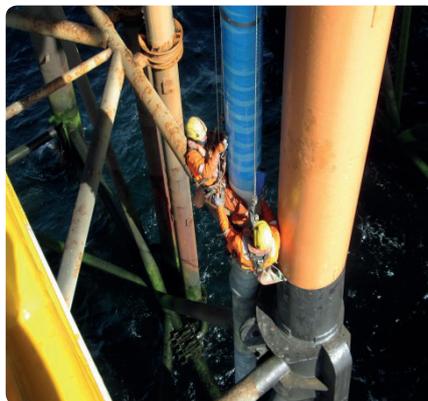
This time, the inspection revealed that the caisson was in poor condition, identifying 10 through hole defects and large areas of deep external pitting at up to 10mm deep.

Stork designed a Composite Repair solution, combining Epoxy Resin, Bio Dur 563 and Gas Pruf primers with the structural qualities of Stork's AquaWrap polymer and field wetted PowerSleeve. This solution delivered an engineered repair with a 20 year life span.

Stork provided a one stop service, carrying out all calculations and design in line with ISO 24817 and PCC2. Furthermore, the repair was successfully implemented by Stork's dedicated multi-disciplined rope access teams.
